Manhole Inspection Summary

Manhole # S35M__035MH

Location Address: **10 e. lee**

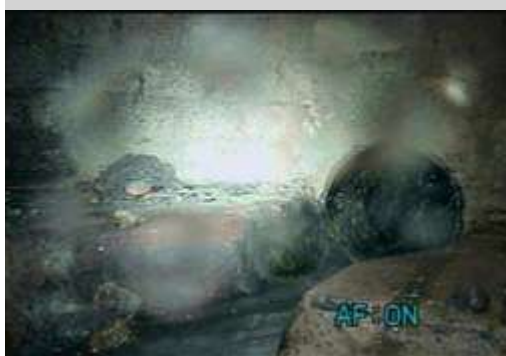
bench debris

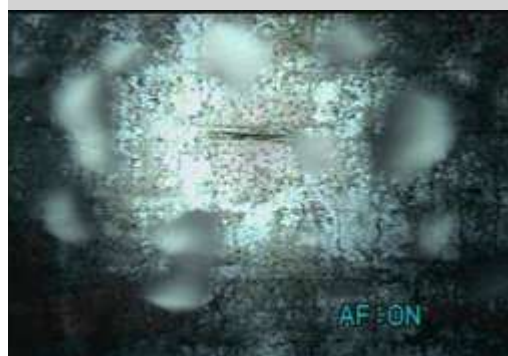
Defect 5

crack in barrel, more missing mortar at 3

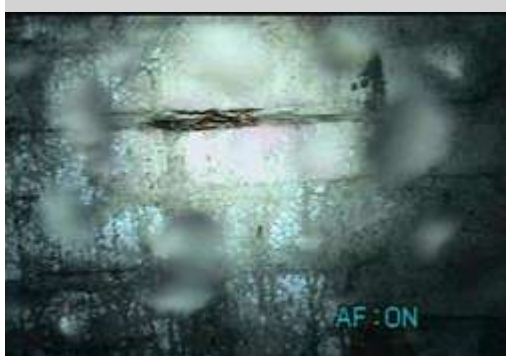
Defect 4

missing mortar at 3 in barrel

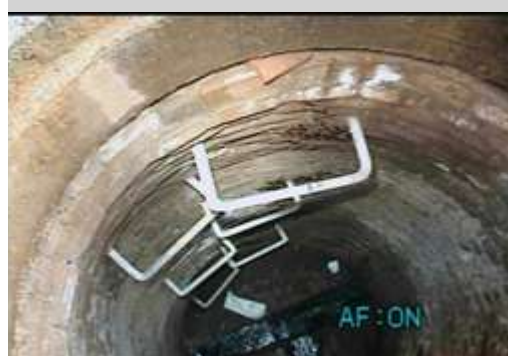
Defect 2

Count: **7** Missing: **0** ☒ **Corroded**

Steps

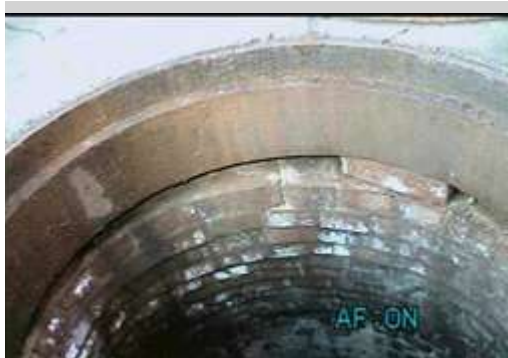
Defect 1

☒ **Leaks**

Condition: ☐ Sound ☐ Cracked ☐ Root Intrusion ☒ **Loose Brick** ☒ **Deteriorated**

chimney loose bricks,deteriorated, frame leaks

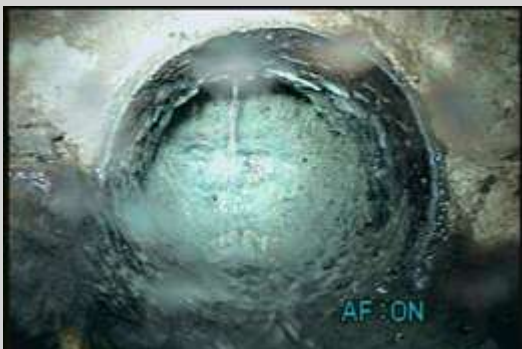
3 O'Clock Inflow

Deposits: ☐ None ☐ Mud ☐ Sludge ☒ Debris ☒ Grease

Silt Depth: 8 (in.) Deposits Extent: Heavy

Infiltration: Dripper Pipe Seal Cond: Cracked

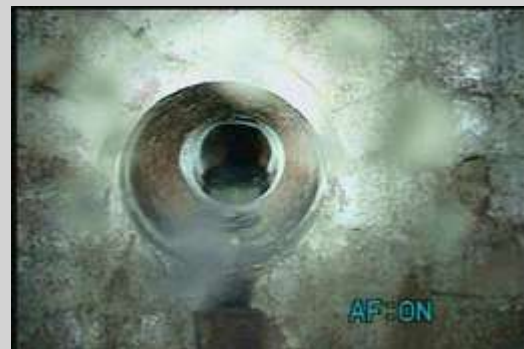
Drop In @ 3 O'Clock

Drop: Outside Direct

Drop Condition: Open
